WIRE STRIKE REPORT

WIRE STRIKE MISHAP ANALYSIS REPORT

Report No. 71-2

**UNITED STATES ARMY BOARD FOR
AVIATION ACCIDENT RESEARCH
Fort Rucker, Alabama**

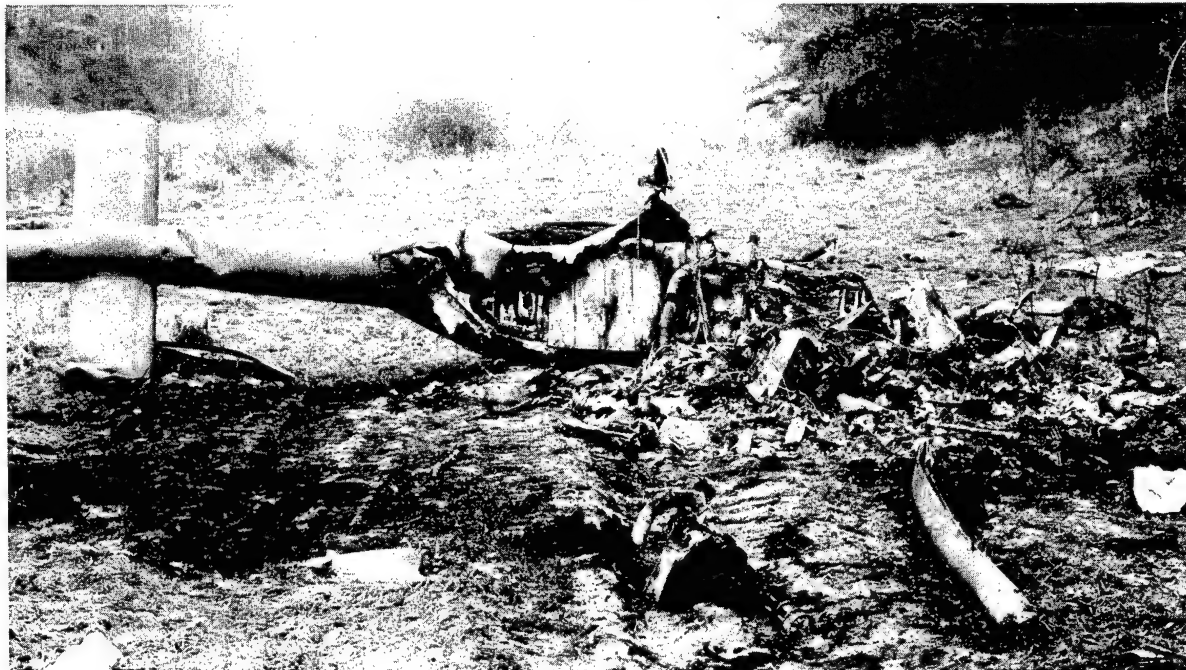
close to the ground. It entered a small valley in which three strands of 1-inch wire cable were strung from power poles on both sides of the valley. The aircraft was flying approximately 30 to 40 feet above the ground with the troop-carrying ship to the left rear and above the lead ship. The pilot of the troop-carrying ship advised the scout ship that the valley contained wires. The pilot of the OH-58 acknowledged and was seen to increase his altitude for a short while and then return to his previous low altitude. After about 1 minute, the troop-carrying ship again advised the OH-58 pilot that there were wires 30 feet to his front. The OH-58 came up momentarily, descended again, and then appeared to climb just prior to hitting the wires. It contacted the wires at 42 feet AGL. Breaking through the wires, the pilot made a left pedal turn approximately 200 degrees and the OH-58 continued to the ground in an apparent controlled attitude. Upon impact with the ground, it exploded into flames and came to rest on its left side. There were two fatalities. The cause of the accident was attributed to the aviator flying at an unnecessary low altitude and high air-speed for mission accomplishment and failure to respond to a warning of imminent wire dangers.

OH-58 pilot flew too low and helicopter struck wires, crashed, and burned.

A probable or suspected cause was listed as improper supervision within the unit of flight planning procedures, disregard of basic safety regulations, and false impression on the part of the pilot that the powerlines ran parallel to the intended route of flight.

It was recommended that:

1. Proper flight safety rules be established and strictly adhered to prior to initiation of concept testing.
2. Current wire maps be made of all areas that are to be used for training. Dissemination

and input of wire information should be spelled out in SOP's. Individuals should be responsible for carrying currently posted wire maps.

3. Preflight briefings should be comprehensive and include weather, wire location, and heights of any known obstruction to flight.

4. Command emphasis be placed on procurement of Nomex fire retardant flight suits and gloves.

5. All wires in major training areas be marked with reflective devices.

6. The fuel cell of the OH-58 be redesigned or included in the Army aircraft program of construction of self-sealing, high impact strength fuel cells.

7. A high reconnaissance of areas be conducted prior to initiation of any low level flights through the area.

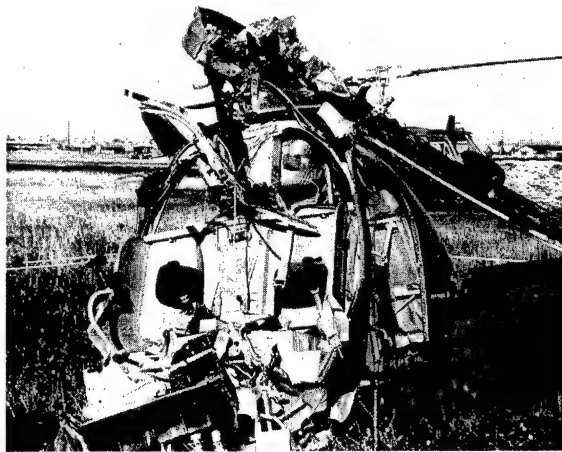
The pilot of an OH-6A was preoccupied by the low level visual recon he was making and failed to see wires stretched between two spans of a river bridge. A wire caught the left skid, ripping it off and sending the helicopter into a left nose low attitude. It hit the water at an estimated 80 knots and sank. The crew of three escaped with one minor injury.

Wire caught left skid of OH-6A during low level recon of river. Helicopter crashed in water and sank.

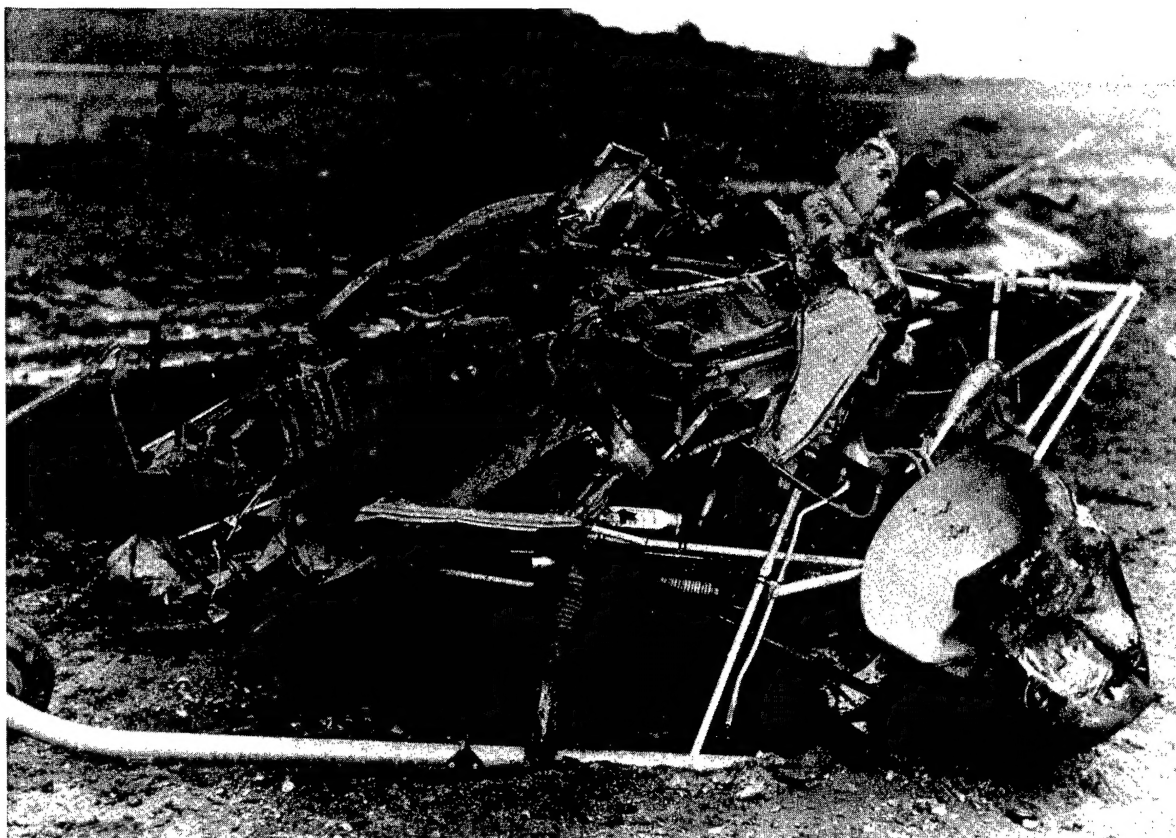
Although restricted visibility is not a significant factor in the overall wire strike problem, this report did reveal cases in which visibility was involved. For example, a TH-55A crashed when the instructor pilot and student were on a cross-country navigation training flight. The instructor pilot was one of two controlling other cross-country aircraft. Shortly after takeoff from the second landing point, the IP transmitted that he was penetrating a squall line. Approximately 1 hour later, the TH-55 struck two high voltage powerlines, resulting in total loss of the helicopter and two fatalities. The cause of this accident was established as operator error, caused by flying in weather that was less than prescribed VFR minimums at an altitude less than 500 feet above ground level which was in violation of written directives.

The probable or suspected cause was listed as supervision due to failure to adequately analyze the forecast weather and the primary controller allowing the TH-55A and his own helicopter to be flown in weather conditions which were less than prescribed VFR minimums. It was recommended that:

IP violated written directives by flying too low and TH-55A struck high voltage powerlines and crashed.

1. Current directives concerning minimum flight altitudes be reviewed with all personnel, with emphasis being placed on strict compliance with all directives.
2. Current directives concerning how to conduct missions in marginal weather conditions be reviewed with all personnel.
3. All personnel receive instruction in the interpretation of current weather forecast terminology.
4. The importance of closely monitoring

weather briefings be emphasized to all flight personnel.
